SCHOONER LANDING RESORT NEWPORT, OREGON

Crack Problems Down the Drain

Challenge: Stabilization of coastal landslides by drainage can be problematic due to low-permeability earth materials.
Solution: Intercept high-permeability graben features and landslide-induced cracks with deep drains exiting onto the beach.

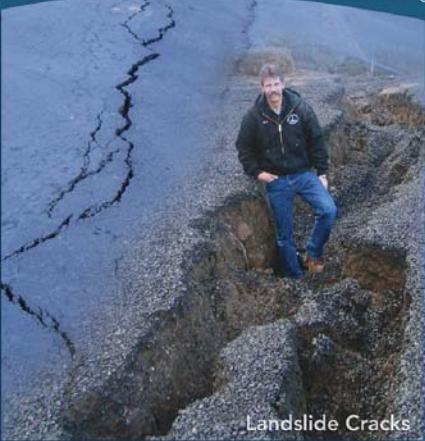
Landslide Cracks

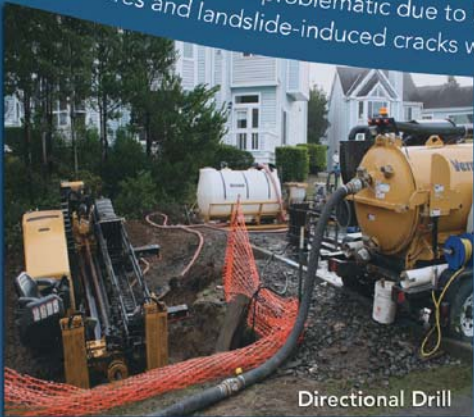
Directional Drill

Directional drill methods were successfully adapted to horizontal drain installation. The launch point for each drain was from the "top" of the site and toward the beach, rather than from a traditional starting point at the "bottom" upward. PBS installed drains consisting of perforated, high-strength, HDPE pipe. The drains were installed perpendicular to the grabens and cracks of the landslide formation. Directional drill techniques allowed the drains to be precisely located at just below the landslide failure surface in the more active portions of the landslide, minimizing the potential for future damage. The "top" launch site minimizes impacts to the beach environment and provides easy access for installation and future maintenance.

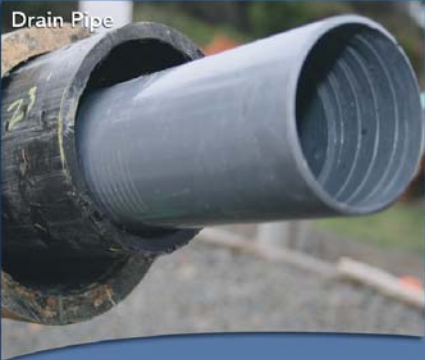
Drain Pipe

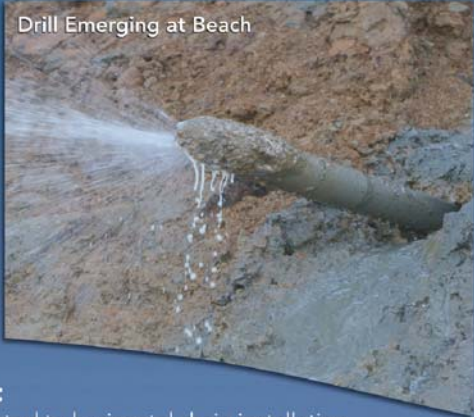
Drill Emerging at Beach

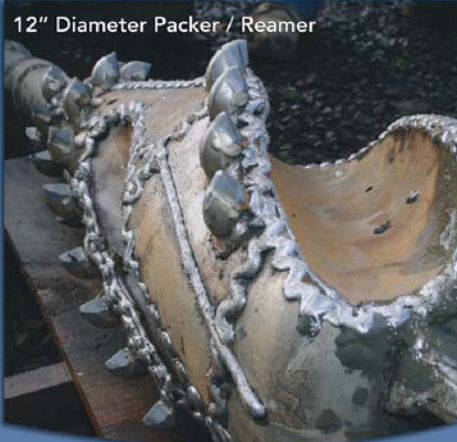
12" Diameter Packer / Reamer
